# Manhole Inspection Summary

Manhole # S3500\_065MH

Insp Date: 1/30/07 12:45 PM

**Location** Address: **114 24TH ST**

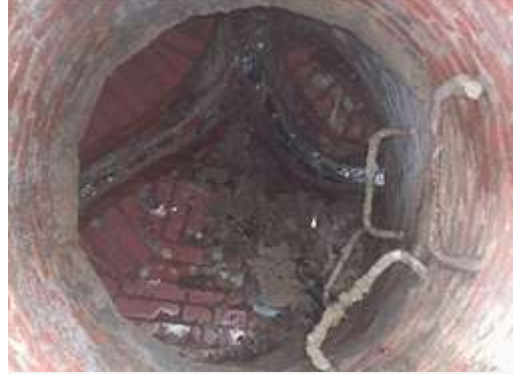
Top View

☒ **Debris** (not Condition related)

Count: **4** Missing: **0** ☒ **Corroded**

Corroded steps. Evidence of surcharge - Bench debris.

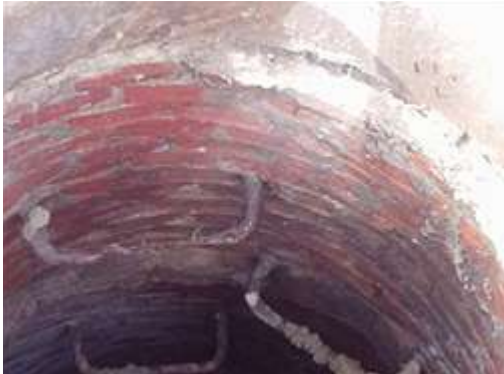
Defect

Offset: **2** (in.)

☒ **Leaks**

Condition: ☐ Sound ☐ Cracked ☐ Root Intrusion ☐ Loose Brick ☒ **Deteriorated**

Infiltration: ☐ None ☒ **Joint** ☐ Cracks ☐ Mortar ☐ Roots ☒ **Wall**

Infiltration: ☐ None ☐ Joint ☐ Cracks ☐ Mortar ☐ Roots ☒ **Wall**

Frame leaks. Frame offset. Adjustment deterioration and infiltration. Corbel and Barrel infiltration.

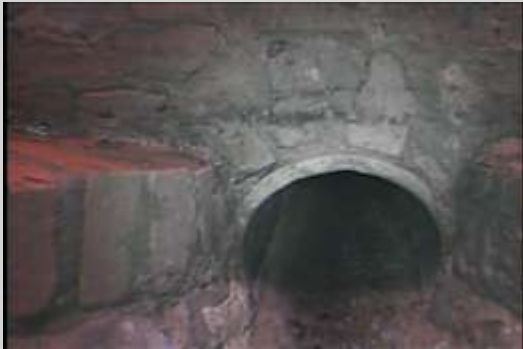
Pipe Out @ 12 O'Clock

Pipe Material: **Clay** ☐ Pipe Lined

Invert Depth: **9.77** (ft.) Flow Characteristics: **Slow**

Infiltration: **None** Pipe Seal Cond: **Unknown**

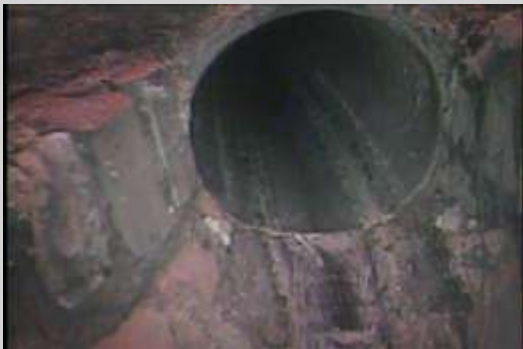
Pipe In @ 3 O'Clock

Pipe Material: **Clay** ☐ Pipe Lined

Invert Depth: **9.25** (ft.) Flow Characteristics: **Slow**

Infiltration: **None** Pipe Seal Cond: **Unknown**

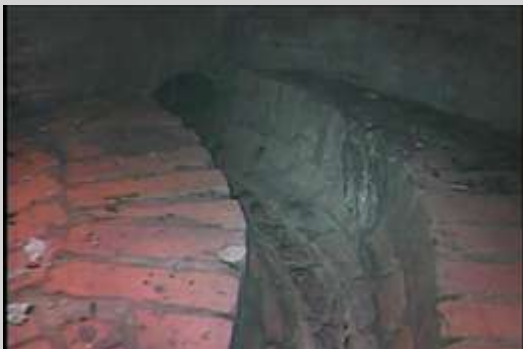
8 in. Circular Gravity Sewer  
Pipe In @ 6 O'Clock

Pipe Material: **Clay** ☐ Pipe Lined

Invert Depth: **8.85** (ft.) Flow Characteristics: **Slow**

Infiltration: **None** Pipe Seal Cond: **Unknown**
